Full-field Deformation Measurement Techniques for a Rotating Composite Shaft

Lee W. Kohlman¹, Charles R. Ruggeri¹,
Richard E. Martin², Gary D. Roberts¹,
Robert F. Handschuh¹

¹NASA Glenn Research Center

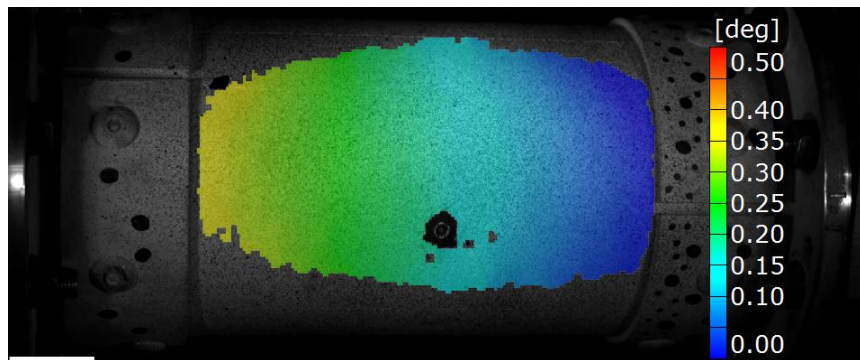
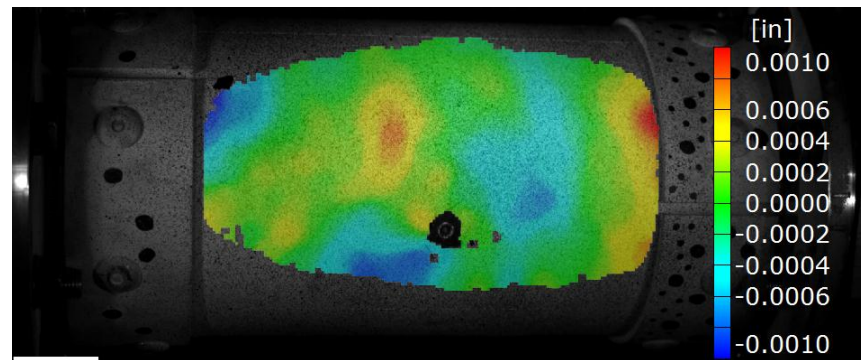
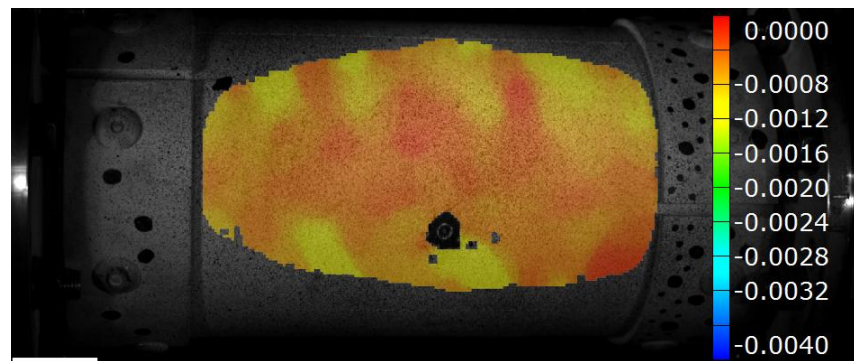
DIC Results: Dynamic, Damaged @ Max Torque (10,000 in-lbs)

Range: -0.001 to 0.001 inches

Range: -0.004 to 0.0000

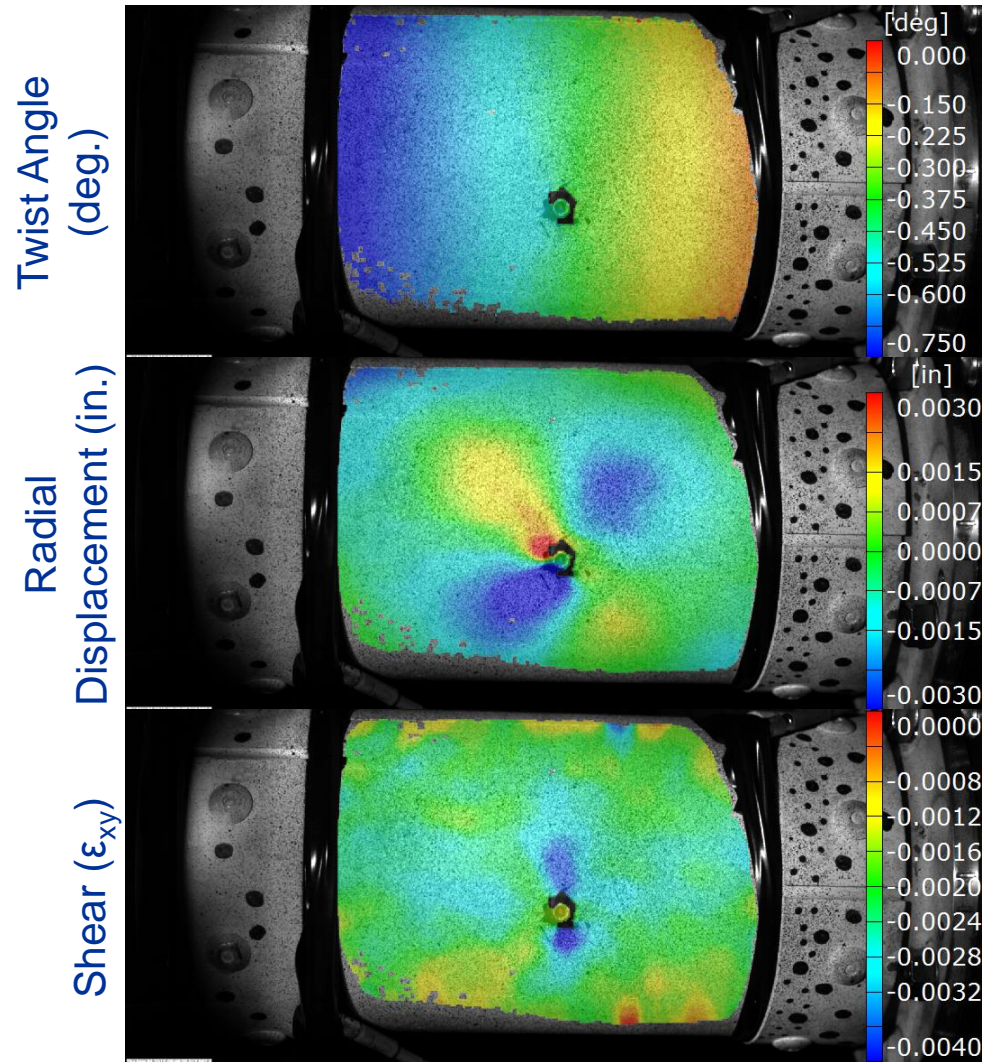
DIC Results: Static, Damaged @ Max Torque (~38,000 in-lbs)

The tube failure initiated at the impact damage location on the back of the tube.

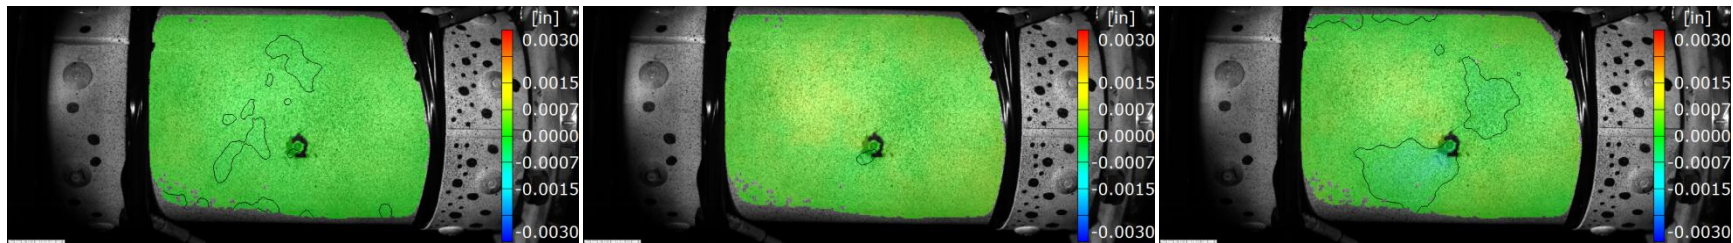
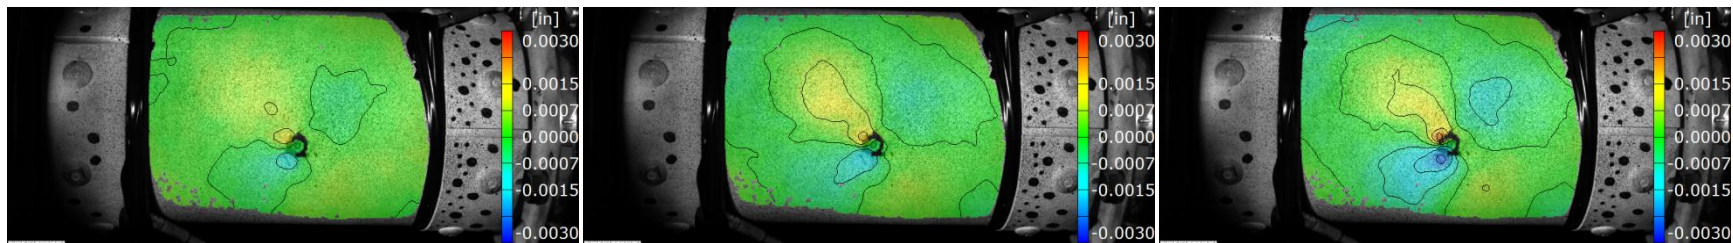
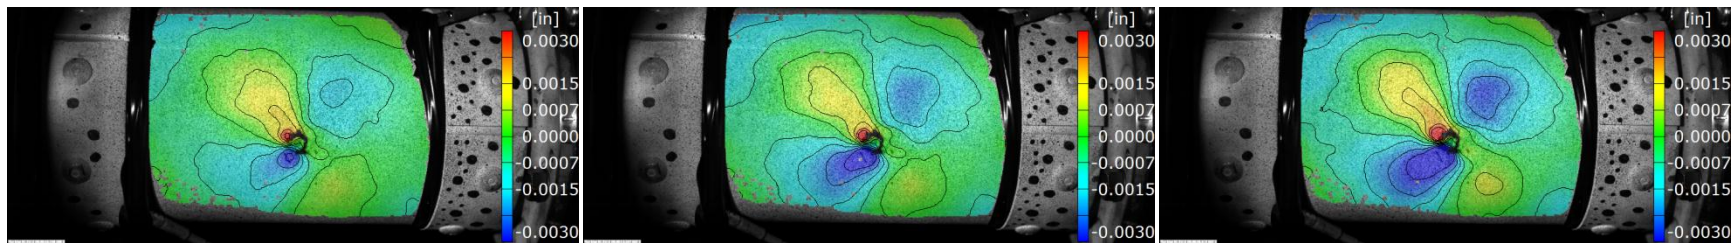
DIC Results: Static, Damaged Radial Displacement (in.)

- Local buckling and delamination resulted in shear failure of the composite tube

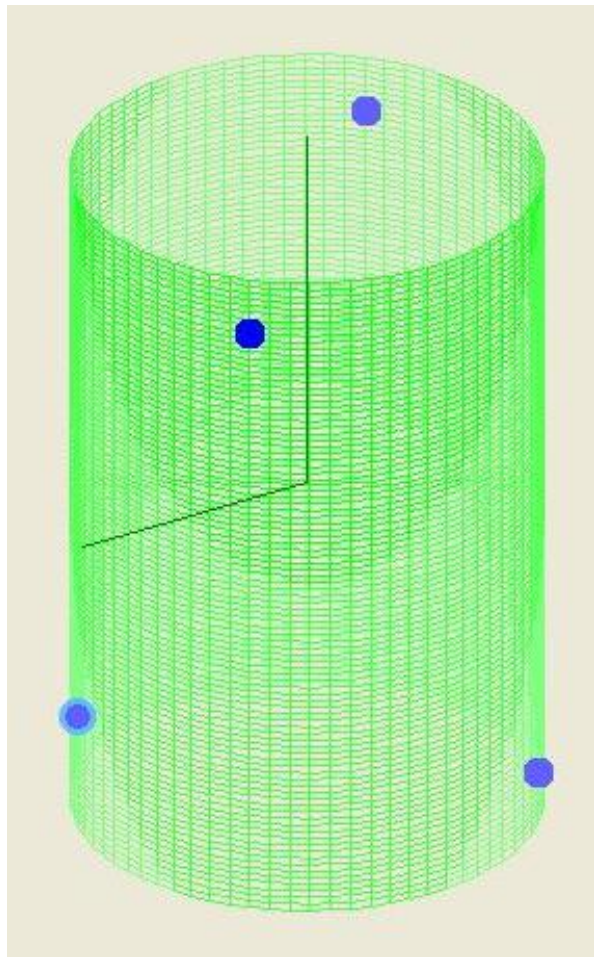
Acoustic Emission Method

- Acoustic emission agrees with the development of additional damage at the impact damage locations
- Near higher loading, damage also occurs in attachment region
